# **Taylor Townsite Habitat Restoration Project As-Built Document, 2007 – 2014**

Sally Nickelson  
Watershed Management Division  
Seattle Public Utilities

January 27, 2015

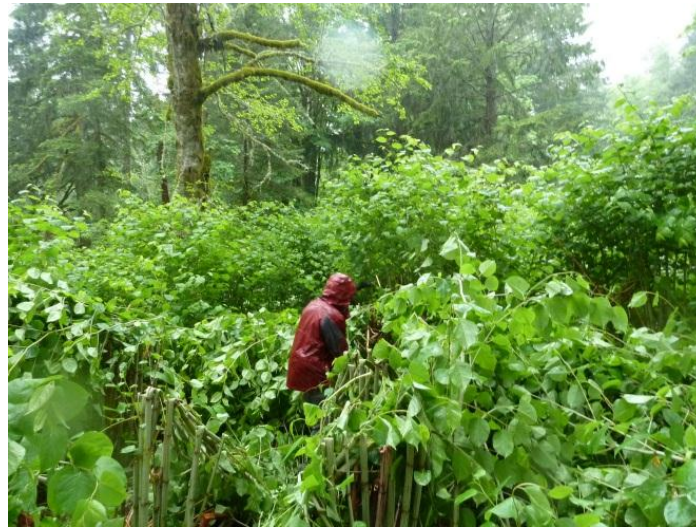
**Figure 6.** Pre-treatment of knotweed by bending canes

The first herbicide treatment at Taylor took place in 2011 on 7.66 acres. Knotweed canes were pre-treated by bending four to six weeks prior to the first herbicide application (figure 6). This allowed sprayers access through the dense mass of canes and ensured the applicators could safely and efficiently spray all portions of the plant. A small patch was missed in 2011 and subsequently treated for the first time in 2012. In 2013 staff did extensive surveys (see following section) and found two more large patches (near the old managers housing and road to the mill). These patches were treated for the first time in 2013 (figure 7). Acreage of knotweed treated annually within the Taylor townsite and ditch now totals 9.3 acres.

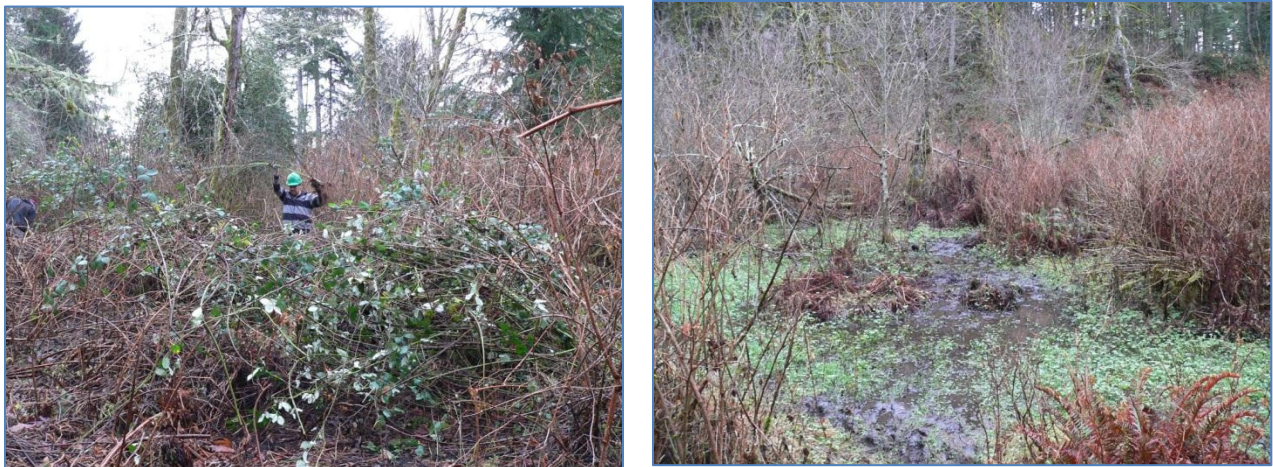
**Figure 10.** During and after blackberry clearing in the Taylor wetland.

We use contract crews to hand-grub the blackberry, removing as much root as possible. We pile the canes and roots and allow them to desiccate on site (figure 10). Once the canes and roots are dead, they are chopped into small pieces and scattered so they decompose more quickly. We started the work in 2011, and continue as funding allows. There were major efforts to clear the wetland in 2013 and 2014. By the end of 2014, the entire wetland had essentially been cleared of invasive blackberry.

The wetland will be cleared of any missed or newly growing blackberry at least every other year for the next several years. Other large thickets of blackberry in high value habitats will be cleared as funding and staffing allows.

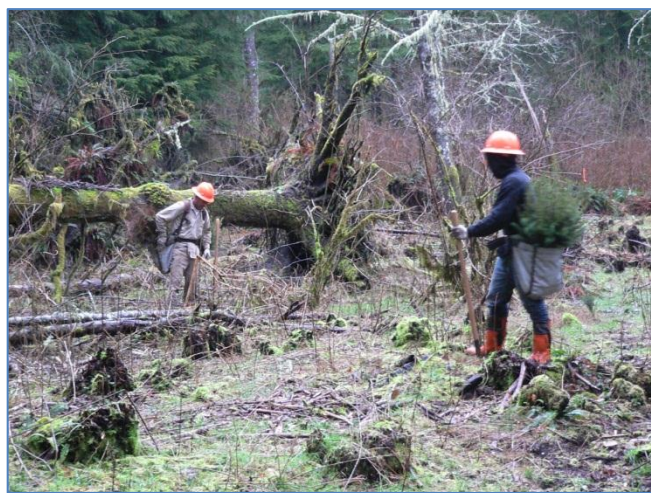
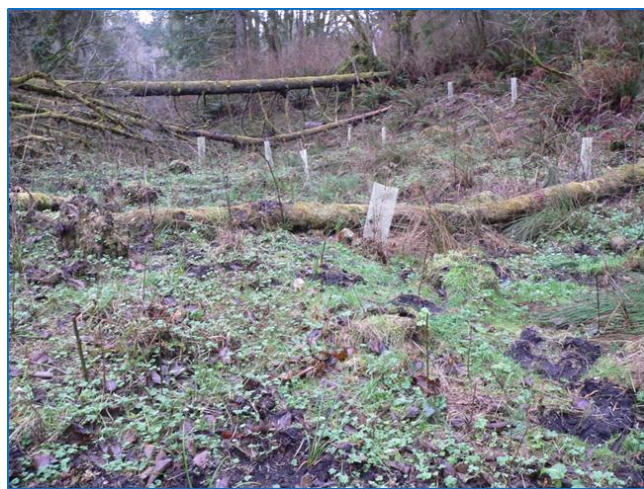
**Figure 12.** 2014 planting in former knotweed-dominated sites.

It was apparent that the diversity of native plant species repopulating the areas formerly dominated by invasive species was limited. In addition, only a few species were present in the vicinity that could provide propagules. As such, in order to increase the number of plant species and provide long-term shade that would help suppress future invasions, in 2014 we planted the wetland and the knotweed sites first treated in 2011. The sites were divided into 13 planting areas, and a specific prescription (species and spacing) was developed for each area (figure 11). A total of 2585 trees (nine species) and 4150 shrubs (20 species) were planted during two planting events (Table 1). Browse protectors were installed around all western red cedar because black-tailed deer (*Odocoileus hemionus*) and elk (*Cervus elaphus*) browse extensively on cedar in the CRMW (figure 12).
